Mersin Photogrammetry Journal

Detection and documentation of stone material deterioration in historical masonry buildings using UAV photogrammetry: A case study of Mersin Sarışih Inn

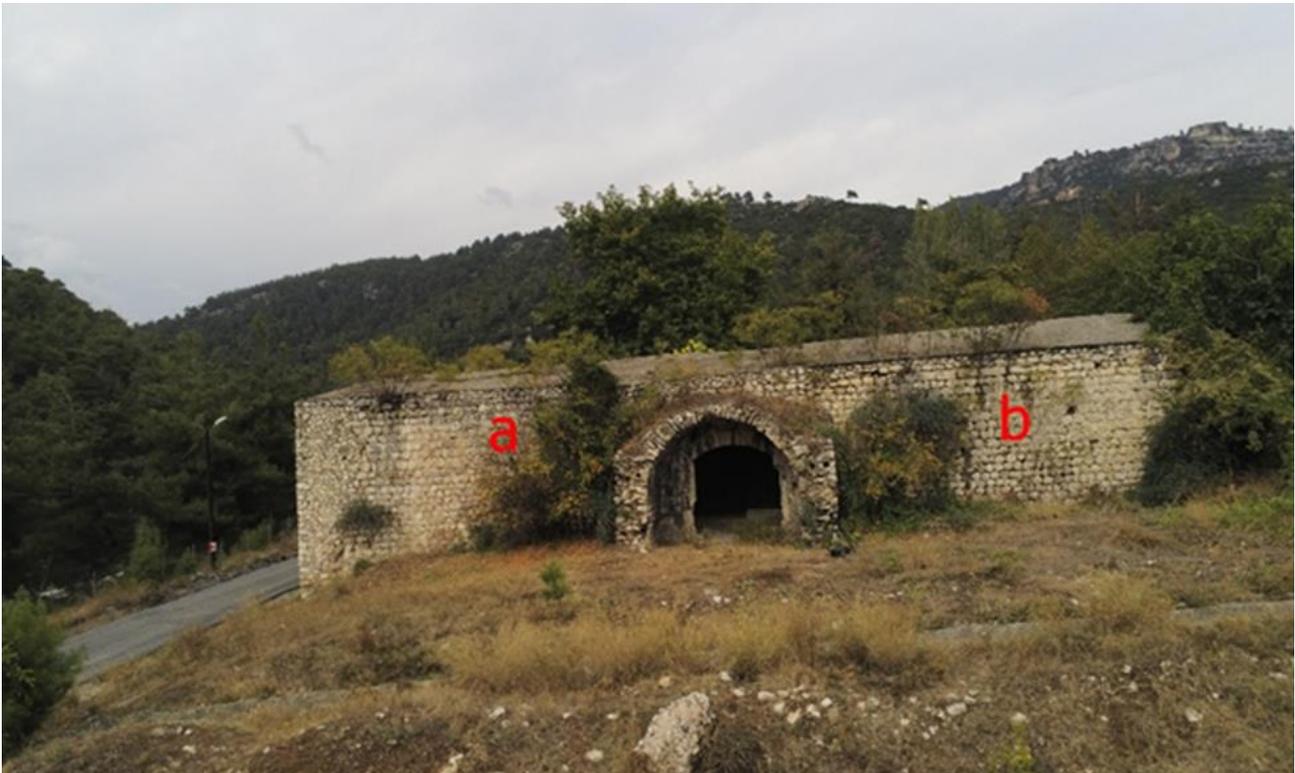
Figure 3. Stone material deteriorations detected on the south façade

In the literature, vertical carriers of building elements in masonry structures are defined as feet, columns and walls. There is no use of pillars or columns in the building. The deterioration in the walls of the building was determined as plant formation and joint loss. On the south façade of the building, there are plants growing in the areas close to the ground where joint loss and joint losses occur due to the effect of water. Joint discharge and plant formation problems were detected on the south façade of the building (Figure 3).

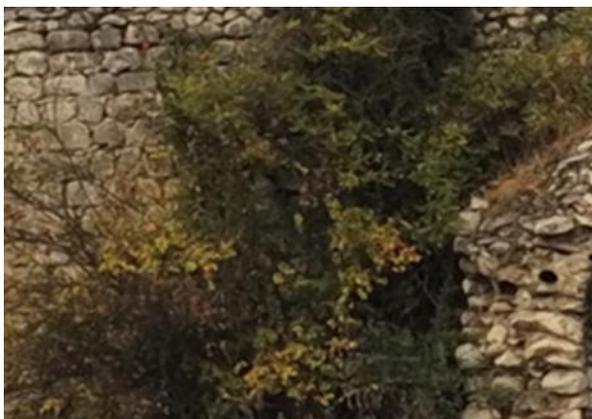
(a) Plant formation

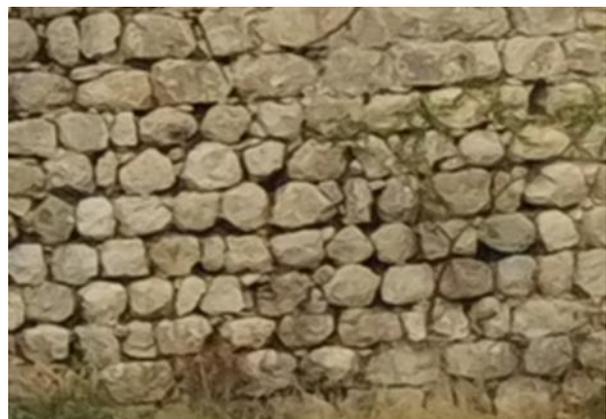
(b) Joint discharge

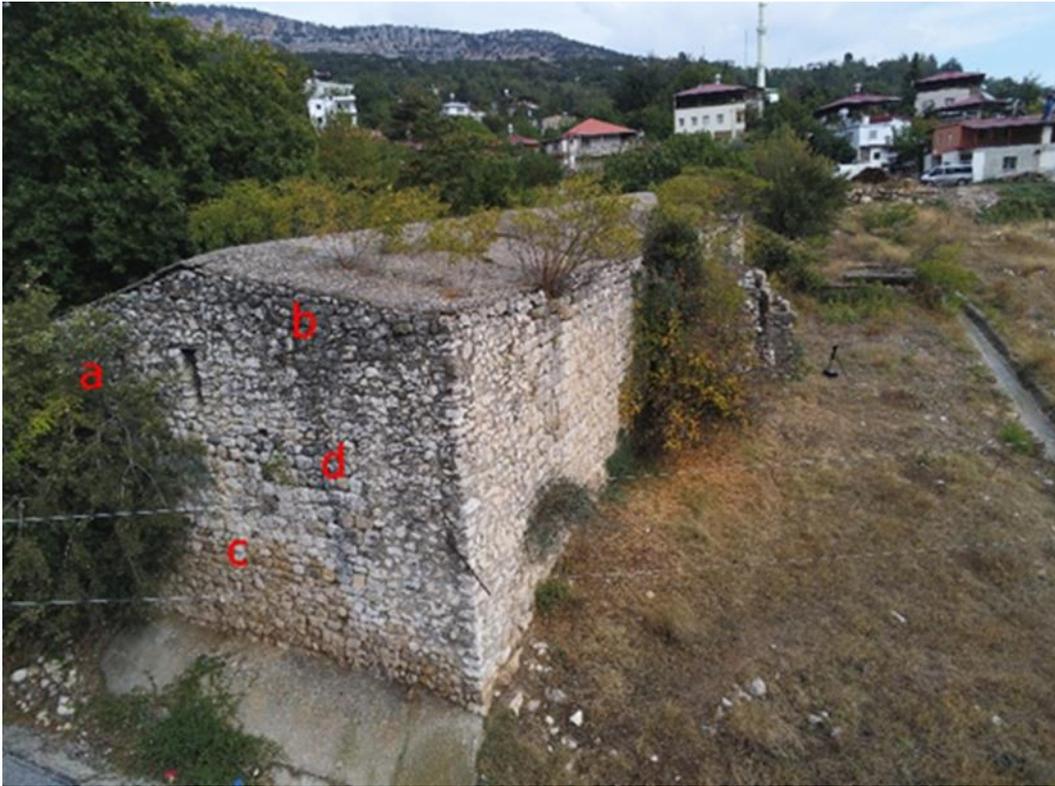
Figure 4. Stone material deteriorations detected on the east façade

On the eastern façade of the building, vegetation, surface pollution, discoloration and joint discharge problems were detected (Figure 4).

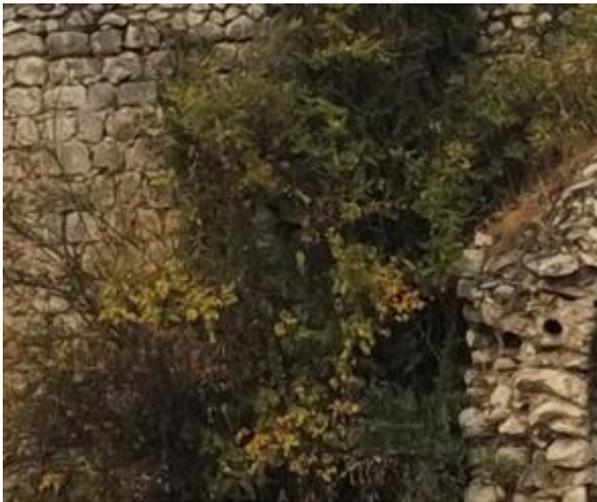
(a) Plant formation

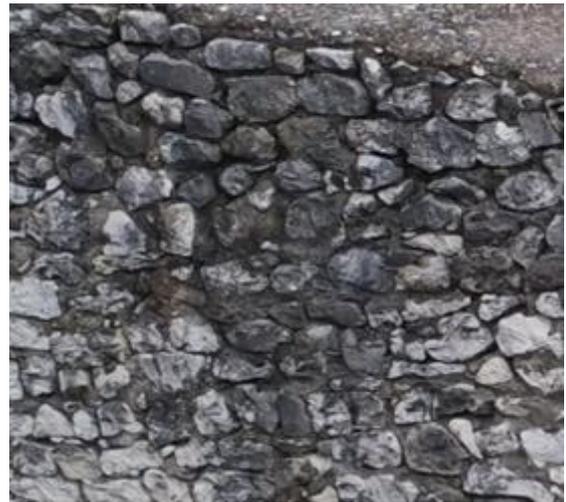
(b) Surface contamination

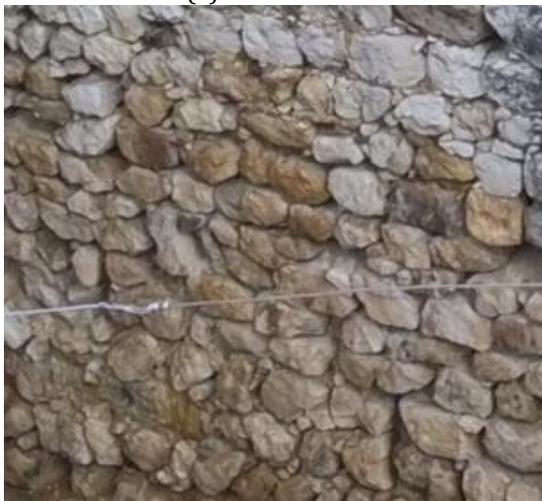
(c) Color change

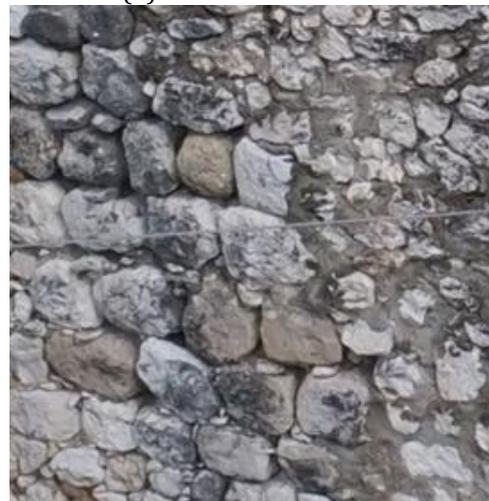
(d) Joint discharge

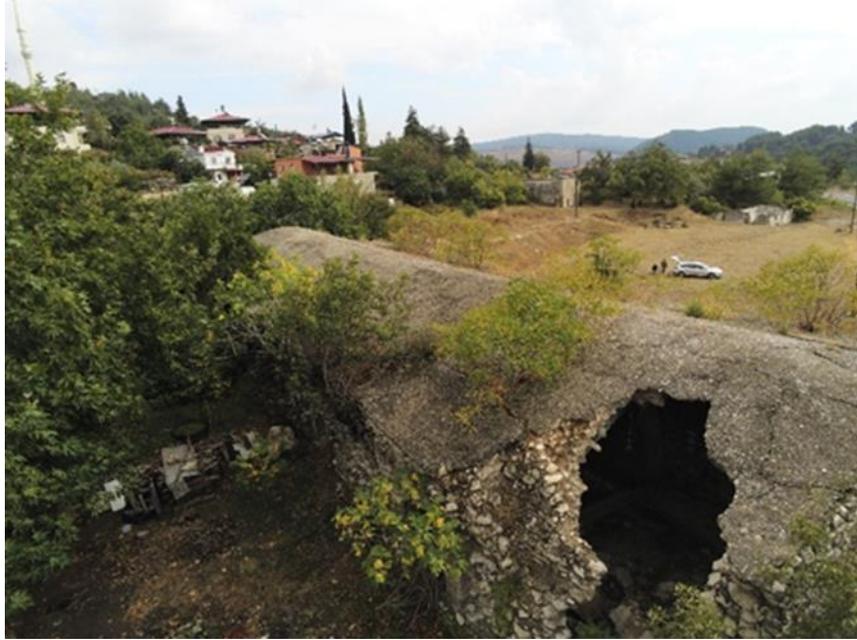
Partial fragmentation problems were encountered as a result of the effects of the loads on the building

caused by the excess plant growth on the northern façade of the building (Figure 5).

Figure 5. Fragment rupture
