Erratum: Determination of Ground-Based Structural Problems in the Historical Four-Legged Minaret with Ground Penetration Radar

Abstract: The Four-Legged Minaret, which has an important place thanks to its building period and unique architecture, is located in the southeastern part of the historical Suriçi region of Diyarbakır. This structure located outside the courtyard of Sheikh Mutahhar Mosque and inside the Dört Ayaklı Minare Street was built on a monolithic stone column from basalt stone in a tetragon plan and is carried by four columns that are in cylindrical form. After 2015, partial damages occurred to the minaret. During the restoration works carried out between 2016-2019, these partial damages were tried to be repaired. But the condition of the ground was not instrumentally detected and investigated in these restoration works. In the present study, observational geological and instrumental geophysical studies were carried out on the Four-Legged Minaret and its surrounding area. The ground condition of the Four-Legged Minaret and the situation of its construction materials were determined by scannings achieved from the ground penetration radar and whether the damages in t

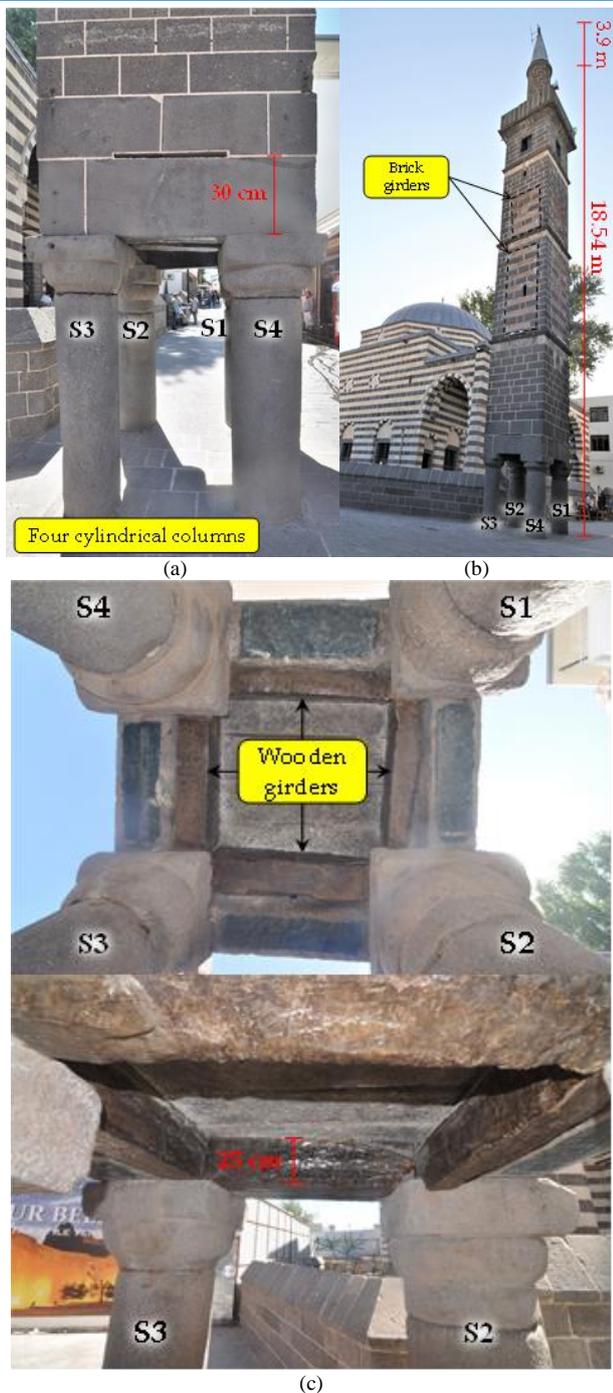
The Four-Legged Minaret is one of these historical buildings and it is located to the northeast of the Sheikh Mutahhar Mosque. The minaret has been repaired and restored many times from the time it was built to the present day in order to eliminate the existing problems in the minaret. However, nowadays, the minaret remained outside the borders of the mosque due to the widening of the street and the introduction of a wall boundary for the mosque, and hence, the minaret remained as an independent minaret in Yenikapı Street (known also as Four-Legged Minaret Street). The square-formed minaret is carried by four cylindrical columns as can be seen in Figure 3a. The minaret, which was built with the masonry technique, has a height of 18.54 m up to the spire and 22.44 m up to the top including the finial as marked in Figure 3b. The main building material used in the minaret is basalt; however, at certain intervals, brick was also used as a girder as indicated in Figure 3b. Besides, there are four wooden girders above the cylindrical columns and under the square minaret base as shown in Figure 3c.

Figure 3. Photographic view of: (a) four cylindrical columns (west view), (b) brick girders (west and north views), and (c) wooden girders (bottom view)

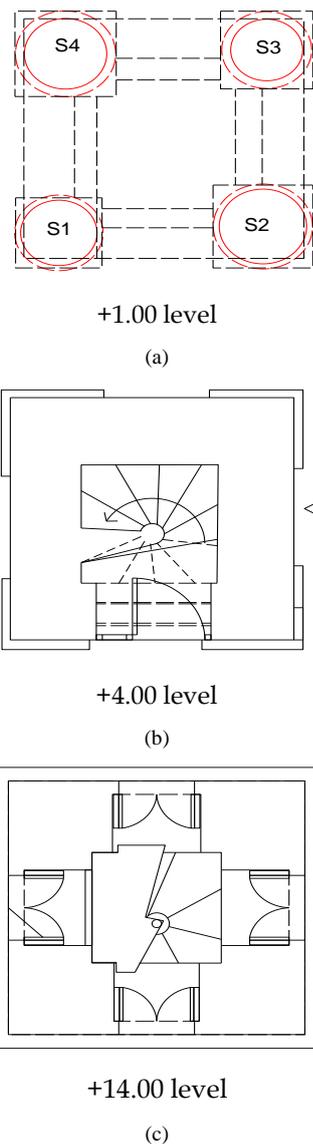
The diameter of each load-bearing column in the Four-Legged Minaret is different from the other: the diameters of the S1 (in the northwest direction) and S4 (in the northeast direction) labeled columns are about 51 and 55 cm, respectively, whereas that of the S2 (in the southwest direction) and S3 (in the southeast direction) named columns are 59 and 49 cm, respectively. For the array and labeling of the columns, see Figure 4a. There are wooden beams having a 25-cm height on these columns as shown in Figure 3c and a basalt lintel with a height of approximately 30 cm above these beams as can be seen in Figure 3a. A spiral staircase that can also be seen in Figure 4b starts after the level of +1.00 m in the minaret.

Figure 4. Plans of Four-Legged Minaret at: (a) +1.00, (b) +4.00, and (c) +14 levels

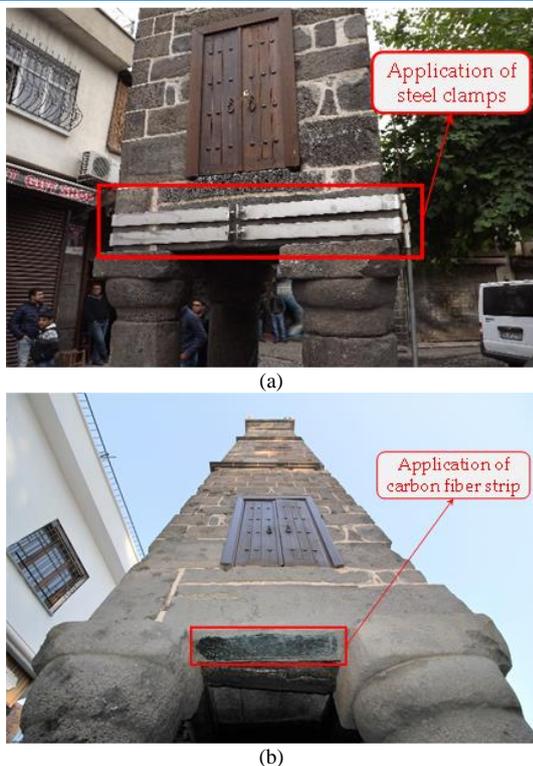
During the restoration work of the Four-Legged Minaret carried out between 2011-2012, the cracks in the north and east directions were reinforced by injection. In addition, steel clamps were added to the lintels as part of this restoration as shown in Figure 5a. However, in 2015, the clamp added around the minaret was removed. Besides, the lintels on the columns of the minaret were strengthened using carbon fiber strips as can be seen in Figure 5b.

Figure 5. Photographic view of strengthening work on the Four-Legged Minaret: (a) application of steel clamps (taken in 2015) and (b) application of carbon fiber strip (taken in 2021)

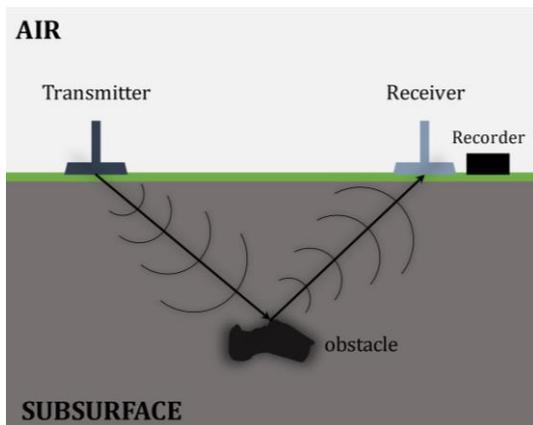
The GPR measuring technique consists of a simple system involving a recording device (computer) and two antennas named receiving and transmitting, as schematically exhibited in Figure 6.

Figure 6. Schematic demonstration of the working principle of a typical GPR system

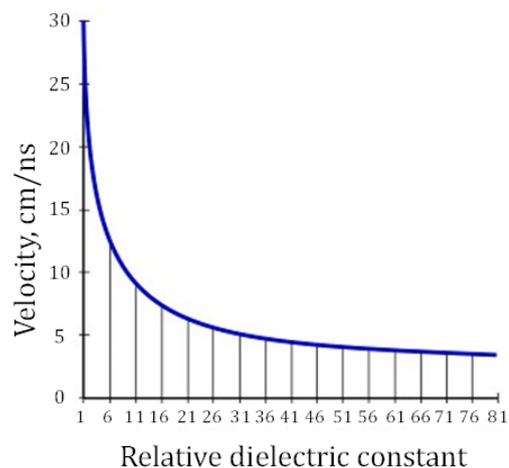
GPR signals arrive at the objective by determining their speed according to the physical and chemical characteristics of the environment it is traveling to, thus collecting information about the target during this travel. In situations where the travel time is known and the speed of the medium is also known, the target depth can be determined with precision. Herein, the most important factors are the signal distribution and the environments in which the travel of electromagnetic signals can be affected. As previously stated, the receiving (R_x) and transmitting (T_x) antennas constitute the GPR system where the short high-frequency radio signals are emitted by transmitting antennas and the signals are picked up by the receiving antennas while being reflected by the obstacle or target, or by layers with different dielectric constant. Unlike seismic reflections, GPR produces reflections from both strata and buried objects. Objects with different electromagnetic properties such as water tables, sediment layers, foundation structures, buried tanks, and archaeological remains lead to reflections in the GPR. In other words, GPR reflections generally occur because objects have different dielectric constants. The dielectric constant reveals how much charge an object can store when an electromagnetic charge is applied to it. In this context, Conyers [27] graphically demonstrated an inverse relationship between radar travel speed and partial dielectric constant, as shown in Figure 7.

Figure 7. The inverse relationship between radar travel speed and partial dielectric constant [27]

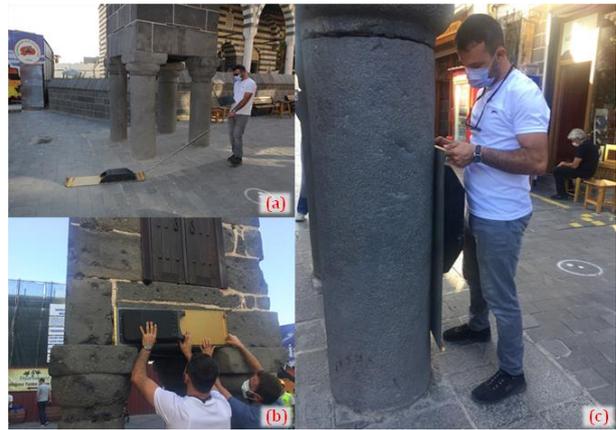
The subject of geological formations, the sequence changes, geometric behavior patterns, underground cavity structures, and dimensions of ground/sub-structure fractures are included in this study. Besides, the conditions and changes of the formations and the classifications according to the characteristics of the host rocks and their electromagnetic permeability were also taken into consideration. In this case, the working area was separated into distinct places, and GPR sections in the shape of lines/profiles were obtained at each of these places. The exact depth capability of the GPR is highly dependent on the antenna frequency, the soil conditions and material properties, the quality and capability of the equipment, and the size of the target. The depth of radar penetration and the ability to identify the target object at any depth depends on the soil properties in that area. If the soil is highly conductive, the GPR method may be ineffective. In this regard, the maximum penetration depth of the GPR into the ground can be determined by the total propagation loss, which is determined by the electrical properties of the materials. Different penetration depths have been determined depending on the GPR equipment and antenna used in this study, the soil characteristics of the area being surveyed, and the size of the target. For example, 4.00 m was designated for scanning the structural elements, while 10 m was chosen as the shallowest and 20 m as the deepest for scanning the ground. Figure 8 shows some representative photographs taken during the GPR measurements.

Figure 8. A typical application of the GPR on: (a) the ground of the surrounding area of the minaret, (b) the basalt lintel of the minaret, and (c) the column of the minaret

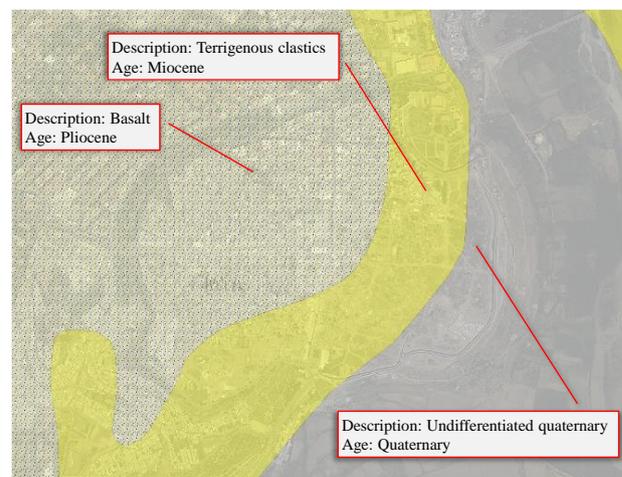
Figure 9. Possible geology map related to the immediate environment of the study area [34]

In regard to the General Directorate of Mineral Research and Exploration, as shown in Figure 9, the geology of the research region and its close surrounds comprises basalt, terrigenous clastics, and undifferentiated quaternary belonging to the Pliocene epoch, Miocene epoch, and quaternary period, respectively. Terrigenous clastics from the Miocene epoch, on the other hand, are widespread in this research region and its close surroundings.

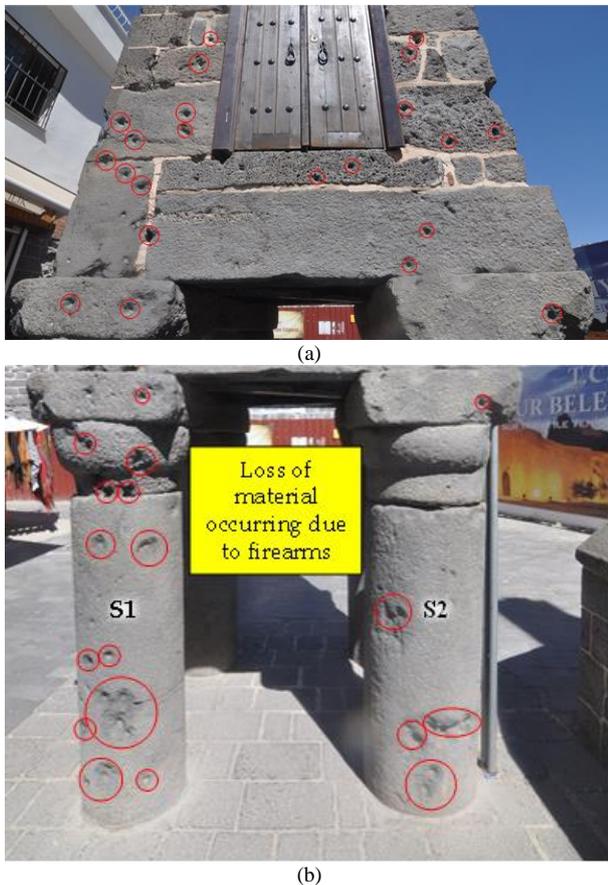
Due to the fact that the minaret was outside the courtyard of the mosque due to its location, partial material losses occurred due to vehicle hits. In addition, in 2015, damage such as fragmentation and abrasion due to firearms occurred on columns S1 and S2 in the northwest direction of the minaret, and bullet holes occurred in some places (see Figure 10).

Figure 10. Photographic views of damages caused by firearms on: (a) the body and (b) columns of the Four-Legged Minaret (taken in 2021)

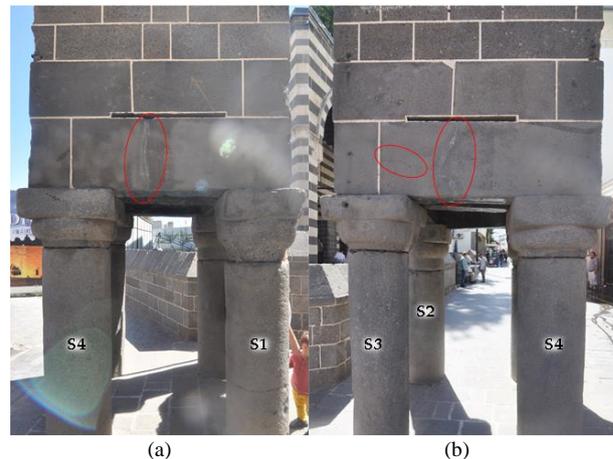
During the restoration work carried out between 2016-2017, no comprehensive repairs were made to the minaret, except for cleaning and removing mortar losses. Especially, there has not been any attempt to complete the material losses in the minaret during the period of vehicle traffic. The existing crack in the lintel of the minaret in the northwest direction was filled with injection during the repair works. In addition, macro-sized (visible) cracks were detected on the lintels on the

columns in the northeast and southeast directions (see Figure 11).

Figure 11. Photographic view of crack damage on lintels on: (a) S1-S4 columns in the northeast direction and (b) S3-S4 columns in the southeast direction (taken in 2021)

To repair the existing damages on the Four-Legged Minaret, comprehensive survey and restoration projects should be prepared under the leadership of the relevant experts, and reinforcement applications should be carried out immediately. In addition to the determination of the damages on the minaret with non-destructive methods, observation pits should be opened in the regions determined by the experts and the physical condition of the ground should be determined. Soil improvements should be carried out around the building, and also columns and walls having axis slippages should be suspended, and reinforcement work should be conducted. In the past years, GPR scanning was not carried out during the restoration works carried out on the ground and load-bearing members of the Four-

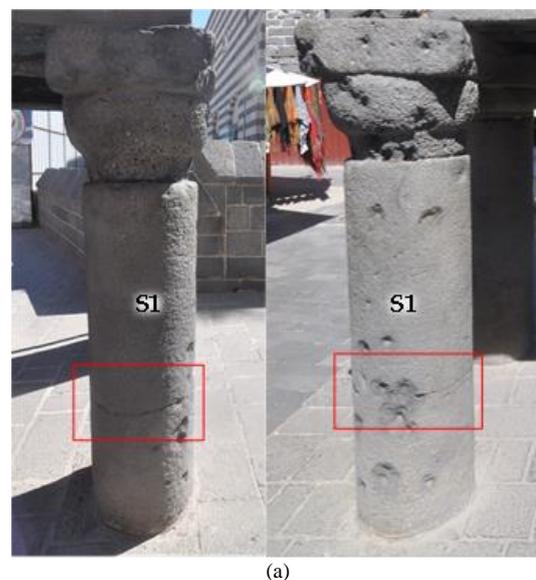
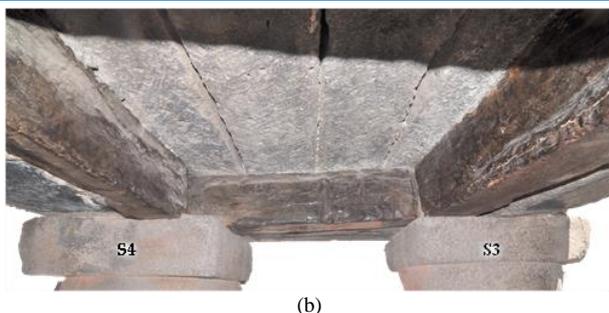
There are level irregularities on the street floor where the minaret is located. Although the street floor where the minaret is located was renewed with cut stone during the repair works, no detailed examination was done on the cause and correction of the level irregularities on the street floor. Besides, partial axis slippage due to vehicle hit, vibration, and level irregularity on the street floor has been observationally detected at the column heads. However, these irregularities and damages were not eliminated during the repairs. In addition, there is a horizontal crack in the middle part of the S1 column due to the loss of material because of the hit of a large number of bullets in that area and the impact of these bullets (see Figure 12). The wooden girders on the minaret columns are original but partially damaged. During the repair work, they were maintained by applying impregnation and protective paint for wood protection, and thereby, the current condition of the wooden girders was preserved.

Figure 12. Photographic view of: (a) the horizontal crack on column S1 and its location and (b) the current condition of wooden girders

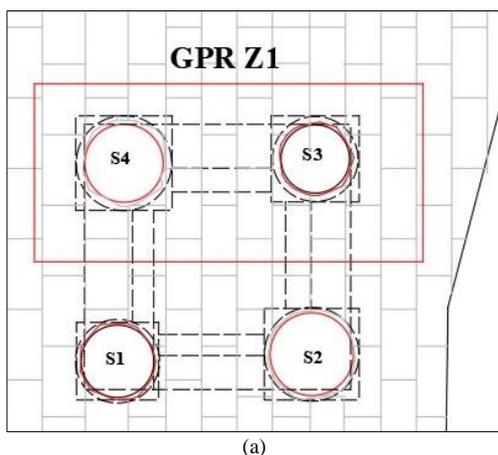
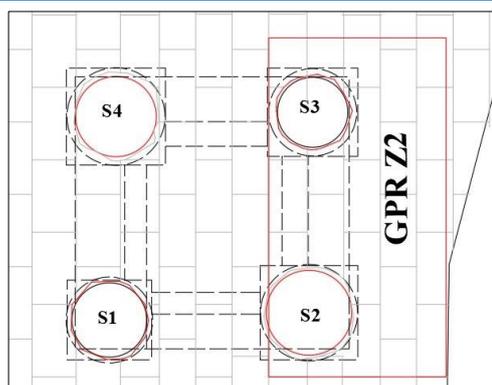
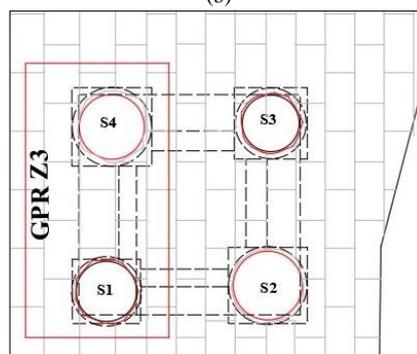
GPR scanings on the ground of the Four-Legged Minaret were carried out by dividing the area into zones. Figure 13 indicates the location and border of each zone in which the GPR scanings were carried out. The GPR Z1 labeled zone had a profile length of 80.0 m while the GPR Z2 and GPR Z3 labeled zones had profile lengths of 50.0 m and 74.0 m, respectively. In all zones, the penetration depth was designated as 20.0 m.

Figure 13. The locations and borders of the GPR scanning zones on the ground (each zone is shown by the box in red color)

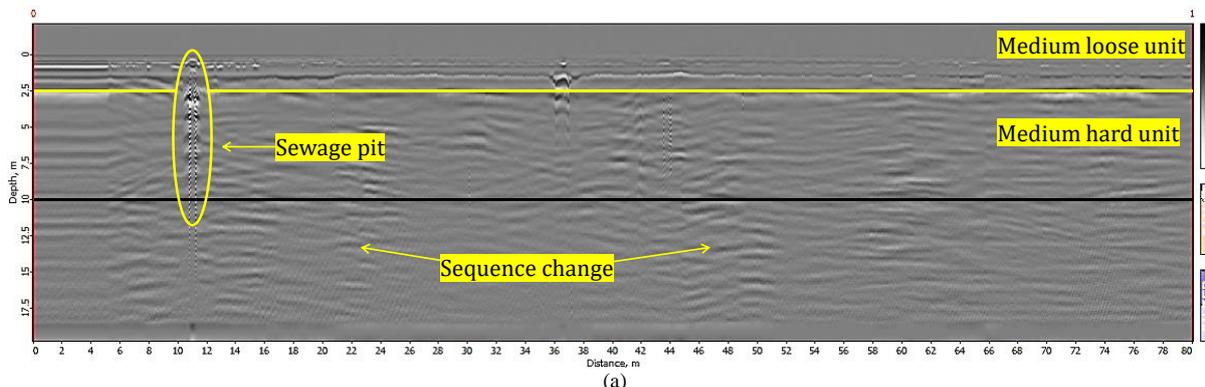
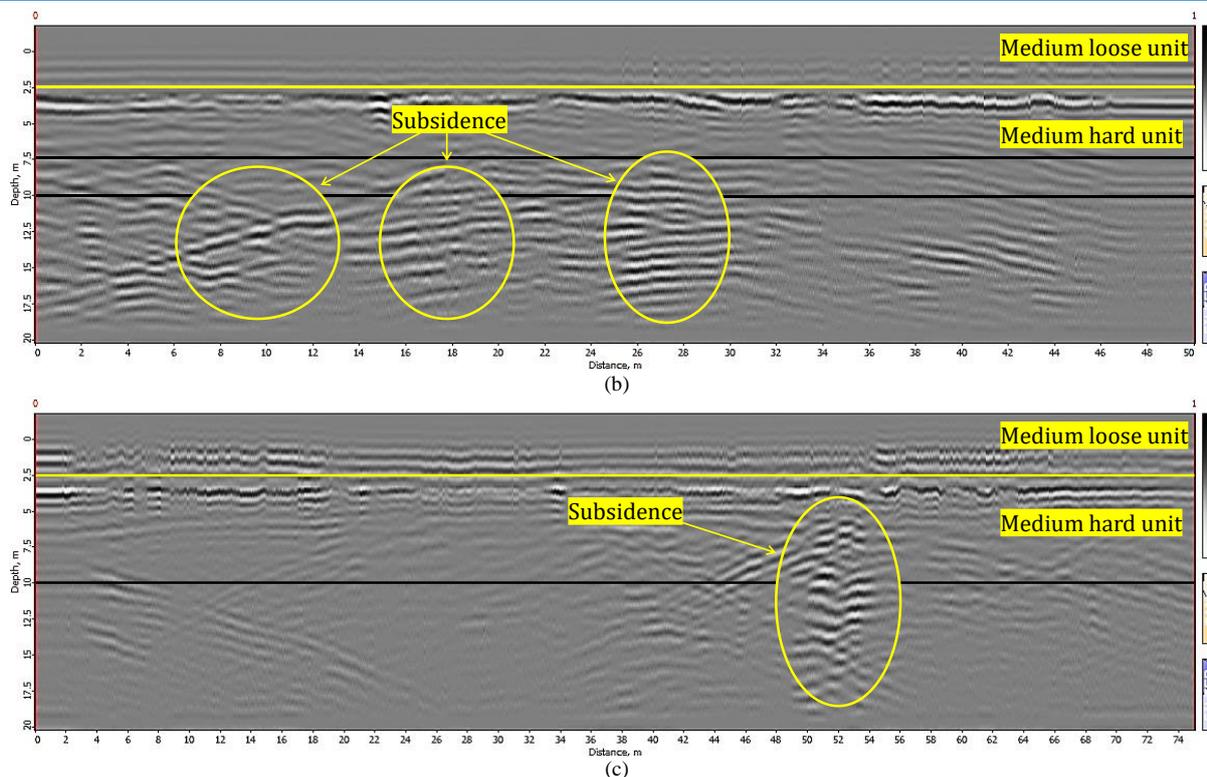
Figures 14a-c demonstrate the 2-dimensional GPR sections taken at zones 1, 2, and 3, respectively. As marked in these figures, 2 different levels were observed from the radargram section of each zone. It is considered to be a medium loose unit of about 2.50 m in the upper part, and a medium hard unit between 2.50 and 10.00 m. As indicated in Figure 14a, there is a sewer pit starting at a depth of 2.50 m and lasting about 10.00-12.00 m throughout the profiling of zone 1. Additionally, in this zone, there is no anomaly formation on the ground, except for the sequence changes. On the other hand, subsidence anomaly formations were identified in the profiling of zone 2. As can be seen in Figure 14b, the regions starting at a depth of 7.50 m lasting through 10.00 and 26.00 m took in water, thus collapsed. In the profiling of zone 3, only subsidence deformations caused by taking in water were detected, as pointed out in Figure 14c. These anomalies are starting at the depth of 5.00 m and lasting through the 50.00 and 52.00 m.

Figure 14. GPR sections: (a) taken at zone 1, (b) taken at zone 2, and (c) taken at zone 3

GPR scans and studies were carried out for the existing damages under the ground and on the load-bearing members of the Four-Legged Minaret in the Suriçi region of Diyarbakır province. In the studies carried out, the current condition of the ground and possible damages and deformations in the load-bearing members were determined and revealed by the radargram sections obtained from the GPR scanings. In the scanings carried out on the Four-Legged Minaret, the conditions of the deformations, their variations, the properties of the surrounding rocks, and their classification according to their electromagnetic permeability were taken into account. As a result of the ground scanning, it was observed that the sequence changes were differentiated at 2 different levels. A medium loose unit was detected from the ground to a depth of 2.50 m, and a medium-hard unit formation was detected between 2.50-10.00 m. It was detected that there was a sewage pit in the scanning zone named GPR Z1 to the east of the minaret. On the south of the minaret, in the scanning zone named GPR Z2, deformations caused by water leakage and related collapse were detected after the levels of 7.50-10.00 m. In the ground scans of the zone called GPR Z3 to the north of the minaret, voids due to collapse were detected in the soil. Some cracks and fractures can be visually seen on lintels in the north and east directions of

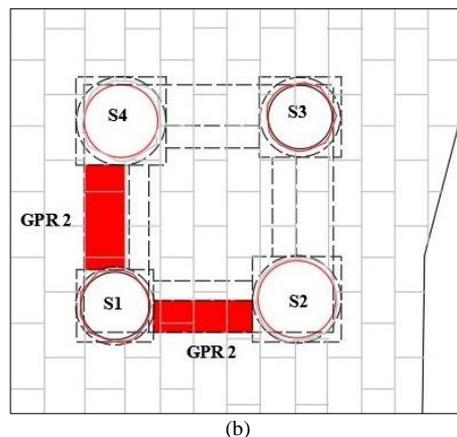
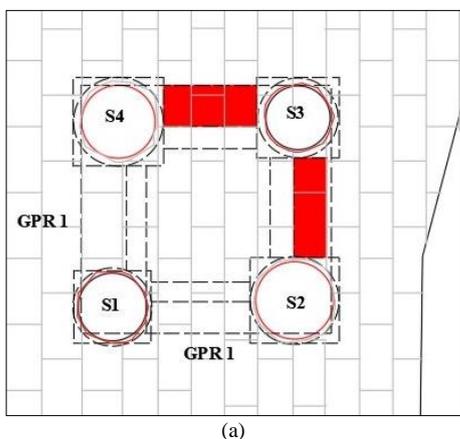
In addition to the GRP scanings on the ground, the lintels on the columns of the Four-Legged Minaret were also scanned by dividing the area into two regions named GPR 1 and GPR 2. Figure 15 indicates the border of each region in which the GPR scanings of lintels were carried out. In the scanning of the region named GPR 1, the profile length was designed as 10.0 m while in the GPR 2 labeled region, it was chosen as 15.0 m. In both regions, the 4.00-m penetration depth was designated. Region 1 involves the lintels on the S2-S3 columns and S3-S4 columns while region 2 includes the lintels on the S1-S2 columns and S1-S4 columns.

Figure 15. The indication of the GPR scanning regions on the lintels (each region is shown by the red color)

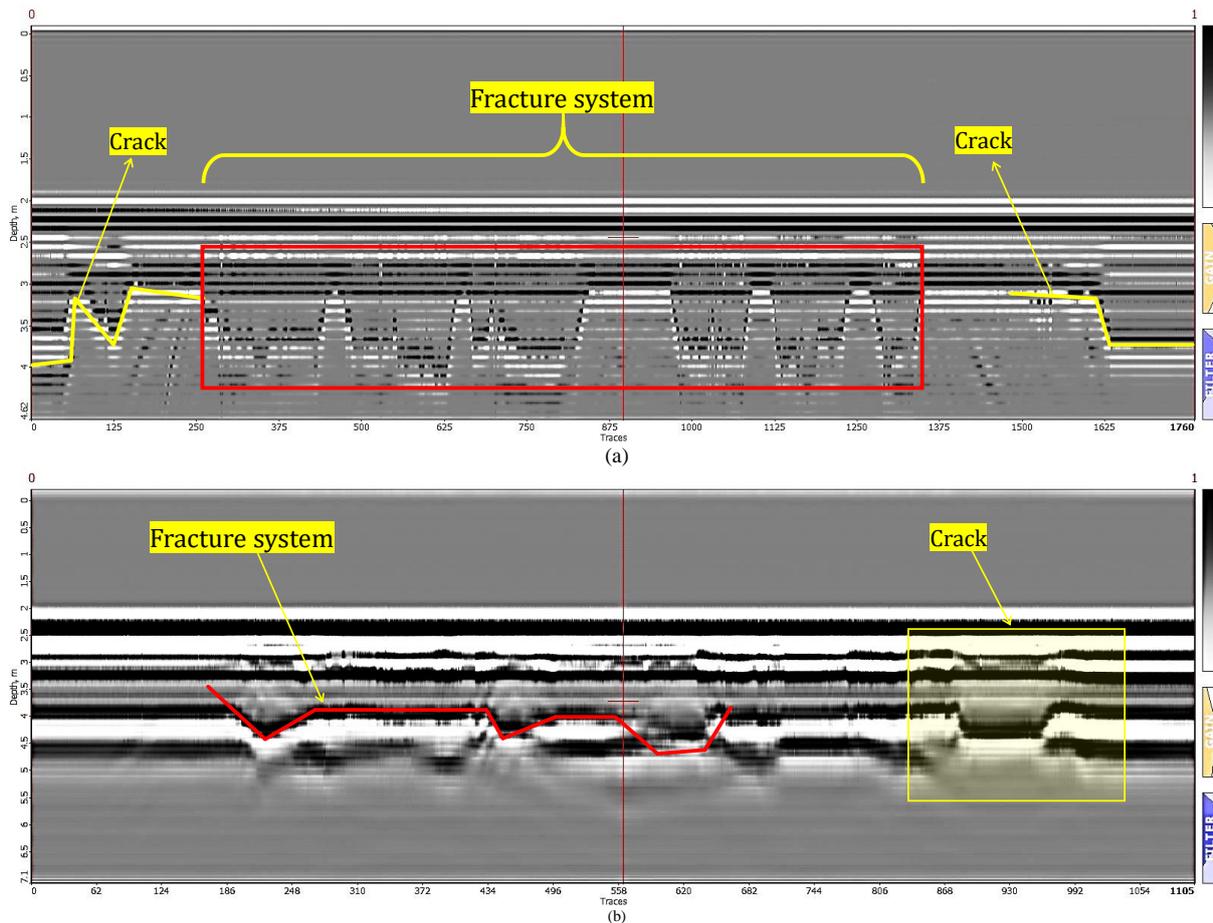
In regard to the radargram section obtained from region 1 (see Figure 16a), it can be stated that it has been observed that the cracks and fractures in the lintels are at a level that will affect the load-bearing system of the minarets. It is considered that cracks and fractures, the smallest 12.00 cm and the largest 20.00 cm, have been detected on the lintels in this area. On the other hand, broken V-type crack systems are at the maximum level in the lintels of region 2, as pointed out in Figure 16b. It is thought that the detected damages on the lintels may adversely influence the load-bearing system of the minaret.

Figure 16. GPR sections: (a) taken at Region 1 and (b) taken at Region 2

the Four-Legged Minaret. During the restoration works carried out in 2012 and 2017, the existing cracks were filled with injections. However, in the GPR scans, it was detected that the existing cracks and fractures continued into the inside of the lintels. On the other hand, fragment losses caused by vehicle hits during the periods when the street was open to vehicle traffic were detected on the columns by observational investigation. In addition, by the time, axis slippages have occurred due to the absence of any tension ring or any protective application between the top caps of the columns and the column bodies. The column diameters of the minaret are close to each other. There are fragmentations and abrasions caused by firearms in 2015 in the columns (S1 and S2) in the northwest and southwest directions of the minaret.
