# Retracted: Architectural Features of the Agora(Bazaar) of the Ancient City of Anastiopolis (Dara)

Dara, Mardin, Architectural Analysis, Stone Masonry, Ancient City

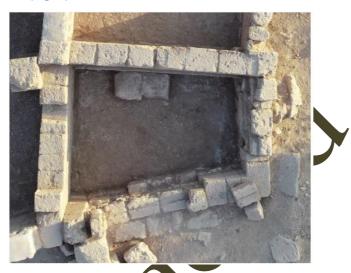
Figure 2. The post-excavation state of shop no. 1.

The short has a geometrically trapezoidal shape rather than a perfect square. Internally, it measures about 4 meters in the north-south direction and approximately 5 meters in the east-west direction. The east wall of the shop is 2.90 meters, the west wall is 4.20 meters, the north wall is 5 meters, and the south wall is 5.20 meters in length. The wall thickness varies between approximately 0.65 to 0.80 meters. While most shop entrances in the agora open towards the east, the entrance of this shop faces the south street. Moreover, the shop entrance is comparatively wider than the others, measuring around 2.5 meters in width. The door jambs and threshold of the entrance have survived to the present day. The fact that the door opens

inward into the shop can be deduced from the jambs flanking the entrance on either side (Fig. 2).

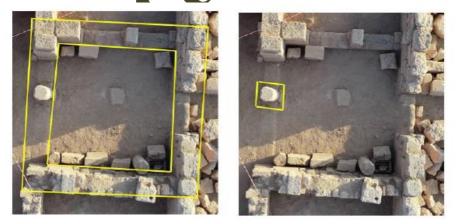
**Figure 7.** (a) Original boundaries of Shop No. 6. (b) Pedestal and column fragment placed on the western wall during the secondary use of the shop.

It is located to the west of the agora (Fig. 7a). Some portions of the eastern, western, and northern walls of the shop are original, while the southern wall belongs to a later phase of secondary use constructed on original foundations. The original walls are built using large block stones. The other wall is constructed by combining large block stones with smaller polygonal stones. The shop has a square plan. The structure measures by meters in both the north-south and east-west directions.

All of its walls are 5 meters long. The wall thickness varies between 0.70 and 0.80 meters. The entrance of Shop No. 6 faces east towards the agora. The doorway is approximately 1.65 meters wide. The doorjambs and threshold of the door have survived to the present day. On the wall that borders the shop to the west, there is a square pedestal with a column on top of it (Fig. 7b). The column supporting the upper structure of the shop has a diameter of about 0.65 meters. Excavation work calried out inside the shop revealed many stones belonging to the upper structure. Most of these stones bear chamfers on their surfaces.

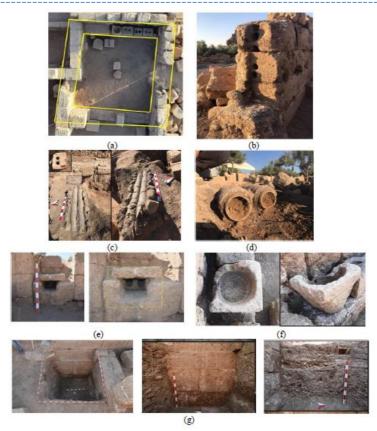
**Figure 8.** (a) The original boundaries of shop no. 7. (b) Indentations belonging to the wooden door system. (c) Tubes of the water system. (d) Location where the tubes of the water system open to the portico. (e) In later phases, hollowed-out for a different purpose from the original.

The shop is situated to the west of the agora (Fig. 8a). The shop has an approximately square plan. The original foundations are observed in parts of the eastern and southern walls, while the other walls are attributed to a second phase of construction on original foundations. In the construction of the shop walls, generally, lime-infused mortar was used. The shop has a square plan, both in the north-south and east-west directions, with a length of 5 meters. All walls of the shop have a length of 5 meters. The thickness of the walls varies between 0.70 to 0.80 meters. The door opening is approximately 1.65 meters wide. Both the door jambs and the door threshold have survived to the present day. Hollows can be seen on the door threshold and the side jambs, which are related to the wooden system of the door (Fig. 8b). In the center of the shop, there are two column fragments with a diameter of approximately 0.52 meters.

These are likely additions from the Islamic period, not part of the original construction of the shop th is probable that these column fragments belonged to wooden supports parrying the upper structure. During the excavations in 2020 a dual new of interlocked tubes forming a water channel was revealed. These parallel channels were likely used for the drainage of wastewater (Fig. 30). Each of the tubes that constituted the water system has an average length of 35 cm and a diameter of about 12 cm. The smaller diameter of the mouth of the tubes allowed them to be fitted into each other to form the system. The fact that this waste water system emerges at a point close to the surface (30 cm deep) indicates its construction in a later period (17th-18th century).

The channels' path has been diverted by stacking three stone blocks, bored through, at the door opening and transferring the channels to the portico in front of the shop (Fig. 8d). It is highly likely that a waste water channel passed in front of the shops. During the excavation, a column capital was also discovered in the area. It appears that, originally, it was a column capital that was later hollowed out for a different purpose (Fig. 8e). In the course of the excavation work, it was observed that the original eastern wall of the shop went deeper from the agora level. In order to reach the foundation of the wall and understand the initial construction phases of both the spops and the agora, a 2 x 2 meter test pit was opened (Fig. 20) Based on the data obtained from the excavation in the test pit, it was observed that the foundations of the eastern walls of the shops assumed to belong to the Eastern Roman period, were approximately 1.55 meters deeper than the agora level. With this information, it is suggested that the agora street might have been constructed not during the initial establishment of the city in the Anastasius period but possibly during the subsequent phase of extensive repairs in the I. Justinianus period (hus ey, 1985).

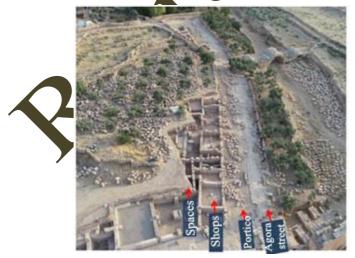
Figure 11. Arrangement of Architectural Structures in the Agora

According to the findings, the Agora of the Ancient City of Dara consists of a stone-paved street, a portico adjacent to the street, and shops/workshops opening onto the portico. In this area where a total of nine shops are found, the shops are arranged side by side, adjacent to the north-south-oriented agora (Fig. 11). Starting from the southern gate of the city, the agora street paved with large stone blocks continues northwards and is approximately five and a half meters wide, extending for about a hundred meters and observable.
