## Restitution process in conservation: Exploring the historical adventure of Derik former government building

Derik Former Government Building, with its architectural structure, is one of the leading examples of civil architecture that reflects the local architecture and construction technique of Derik District of Mardin. The building was registered as the 1<sup>st</sup> Group in 2006 and is not being used today. It has been used in different functions by the local people until today and has taken its current form with the additions made in different periods. In the archive records scanning, no information or document was found that the restoration project was drawn. In this context, it is necessary to reveal the historical evolution of the building in order to ensure the sustainability of the building and to maintain its historical identity. The aim of the restitution research of the historical building is to determine the changes that the building has undergone until today, to find its original state based on scientific data, to find the periods it went through and to lay the groundwork for the restoration work. As a method in the study, comparative studies were made with examp

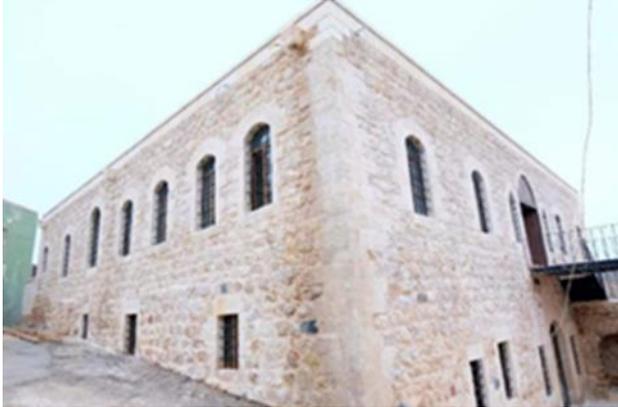
Figure 2. Images of Derik former government building

There are window openings on the southeastern wall, some of which were destroyed. The terrace is the uppermost part and the last floor of the building. There is no parapet on the terrace floor, which has a square plan scheme (Figure 2). There is no building element on this floor.

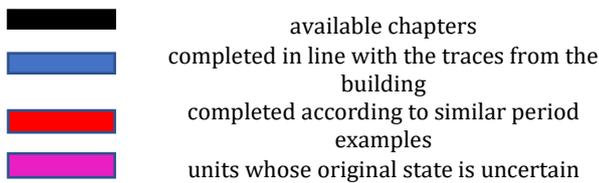
Figure 3. Legend of restitution proposal

As a result of the determinations made from the traces of the building and the determinations made during the survey studies, the existence of which is known for certain, the following findings were obtained regarding the plan and facade features of the 1st period of the building (Figure 3).

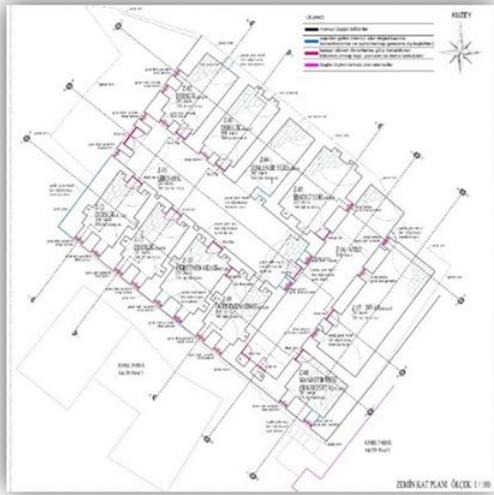
(a)

There is no trace of the original flooring on the ground floor and today it is a cement-based screed. Ground floor coverings were completed according to the original floor coverings used in the upper floor of the building and similar structures. As a result, it has been determined that the floor coverings of indoor and outdoor spaces are a material characterized as cut stone (Figure 4a).

Figure 4. Floor plans and sections of the building

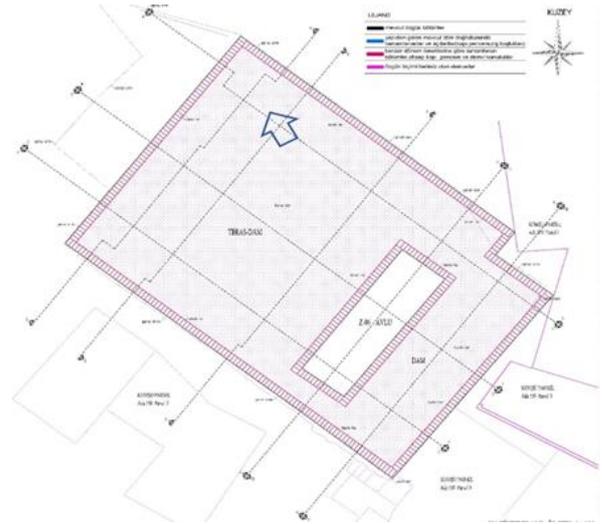
(b)

Terrace-Dam, on the other hand, is the uppermost part and the last floor of the building. There is no parapet on the terrace floor, which has a square plan scheme. There is no building element on this floor. The flooring on this floor was completed according to similar period examples (Figure 4b).

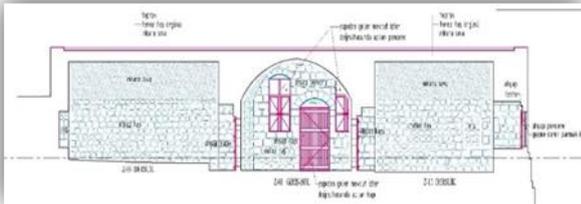
(c)

The door providing the passage to the courtyard on the southeast facade wall in the Z-01 Entrance-Hall and the windows on both sides were opened in line with the existing traces from the building (Figure 4c). The skylight on the northeast wall of the Z-02 classroom was opened in line with the existing traces from the building (Figure 4d). The wall on the southwest façade at the Z-04 Resting Area was completed in line with the existing tracks (Figure 4e).

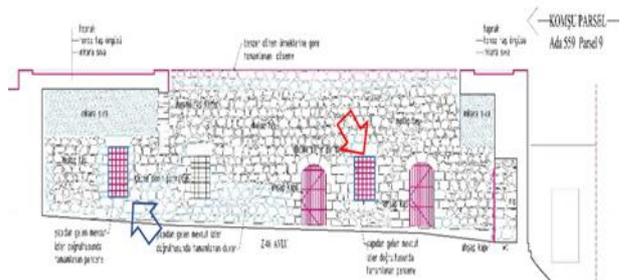
(f)

The door on the northwest wall of Z-6 Courtyard and 2 windows on both sides were opened in line with the existing traces from the building. The partially destroyed window openings on the southeastern wall were completed in line with the existing traces from the building, and the iron railing and wooden joinery were completed based on examples from similar periods (Figure 4f).

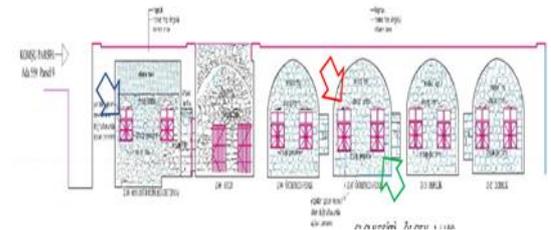
(h)

The partially destroyed window opening on the northwest wall of the Z-07 Divan was completed in line with the existing traces from the building (Figure 4h). The window on the southwestern wall of the Z-08 monastery was opened in line with the existing traces from the building (Figure 4i).

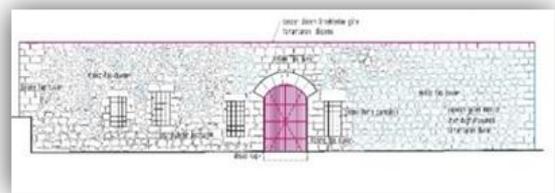
(j)

A comparative study has concluded that the vaulted surfaces have a vault mesh filled with inkara plaster. It was concluded that the floor coverings were also limestone as a result of the comparative study with the examples of similar periods found in the building. In addition, in line with the existing traces in the building, it was determined that the whitewashed areas were rubble and cut stones. The entrance to the building is provided by a round arched door on the northwest street. Based on the examples found in Derik, the wooden door was restored to its original form (Figure 4j).

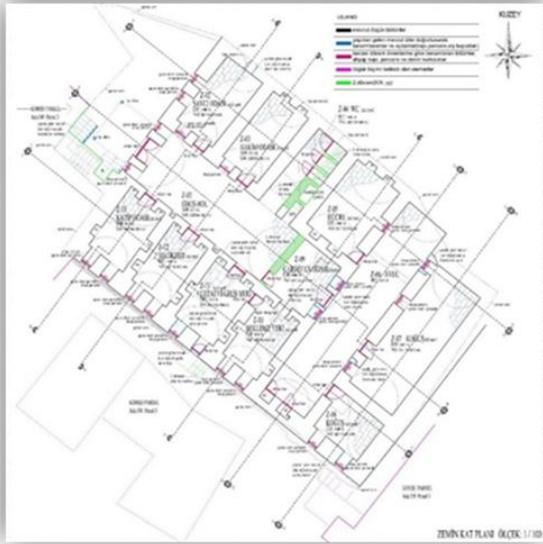
(a) Ground Floor Plan

**Figure 5.** Floor plans, sections and facades of the second period of the building

Another floor was added to the existing first period building at the end of the 19<sup>th</sup> century. Since the municipality organization was established in Derik in 1874, the establishment date of the government office is not known, but it is estimated that it was founded at the end of the 19<sup>th</sup> century. The lower floor of the building was used as a court-prison and the upper floor was used as a government office (District office) (Figure 5).

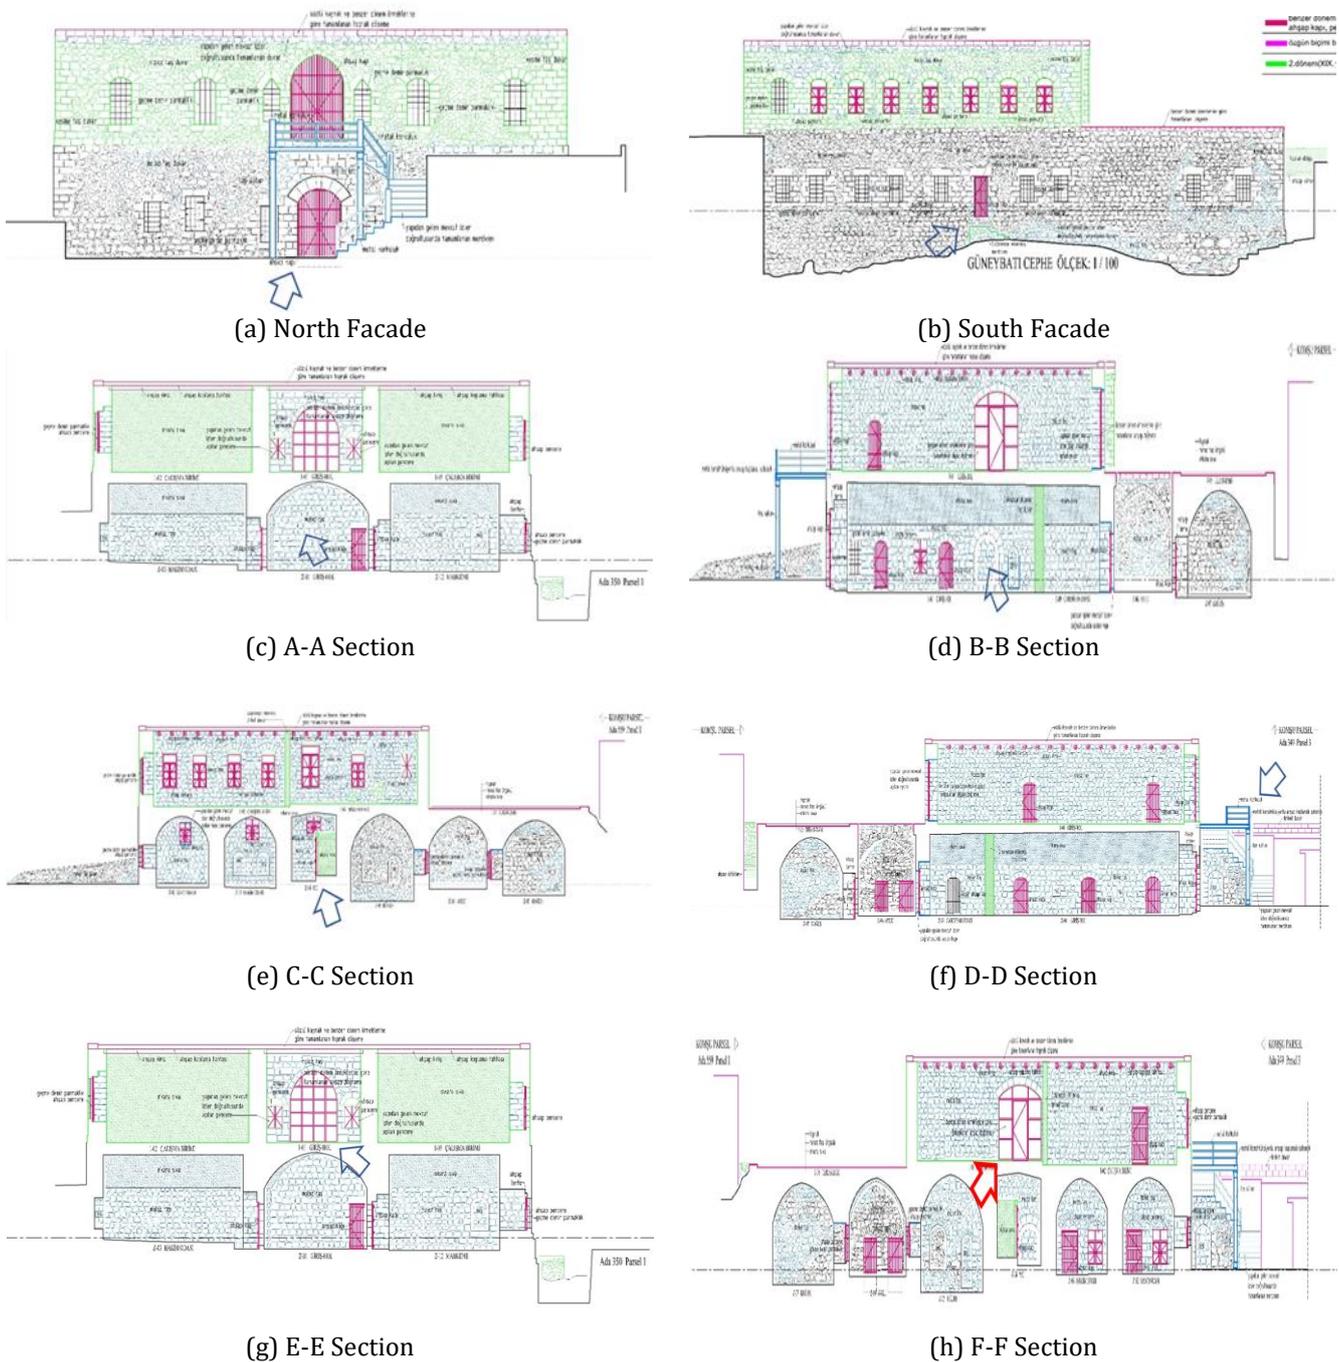
(g) E-E Section  
 (h) F-F Section  
**Figure 6.** The ground floors, sections and facades of the second period of the building

The ground floor of the building was used as a court-prison. Since no data about the building could be reached, it was completed by obtaining information from the people who lived there for many years and in line with the existing traces from the building (Figure 6a). The main entrance to the prison is through the round arched door in the northwest. In addition, the entrance of the prisoners is provided through the door on the southwest facade, which was used as a window in the 1st period. The wooden door has been restored to its original form based on the examples found in Derik (Figure 6b).

In the Z-01 Entrance-Hall, a stone wall was added to the southwest side both to separate the prisoners and to obtain the Warden's Room (Z-09) (Figure 6c). The pointed arched niche in the northwest in the Z-01 Entrance-Hall was lowered to the ground according to the existing traces to provide the entrance to the warehouse (Figure 6d). In Z-04 Wc, 3 separate WCs were created with briquette walls according to the existing traces from the building. In addition, a sewer pit was created in Z-04 Wc to collect the toilet expenses (Figure 6e).

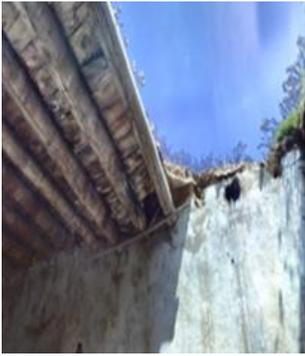
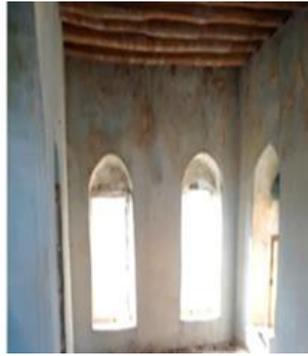
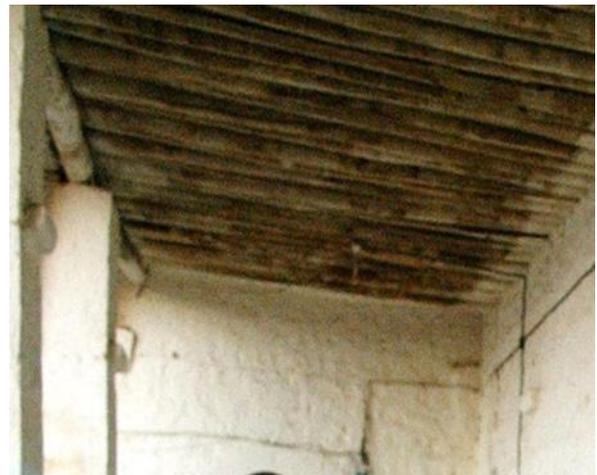
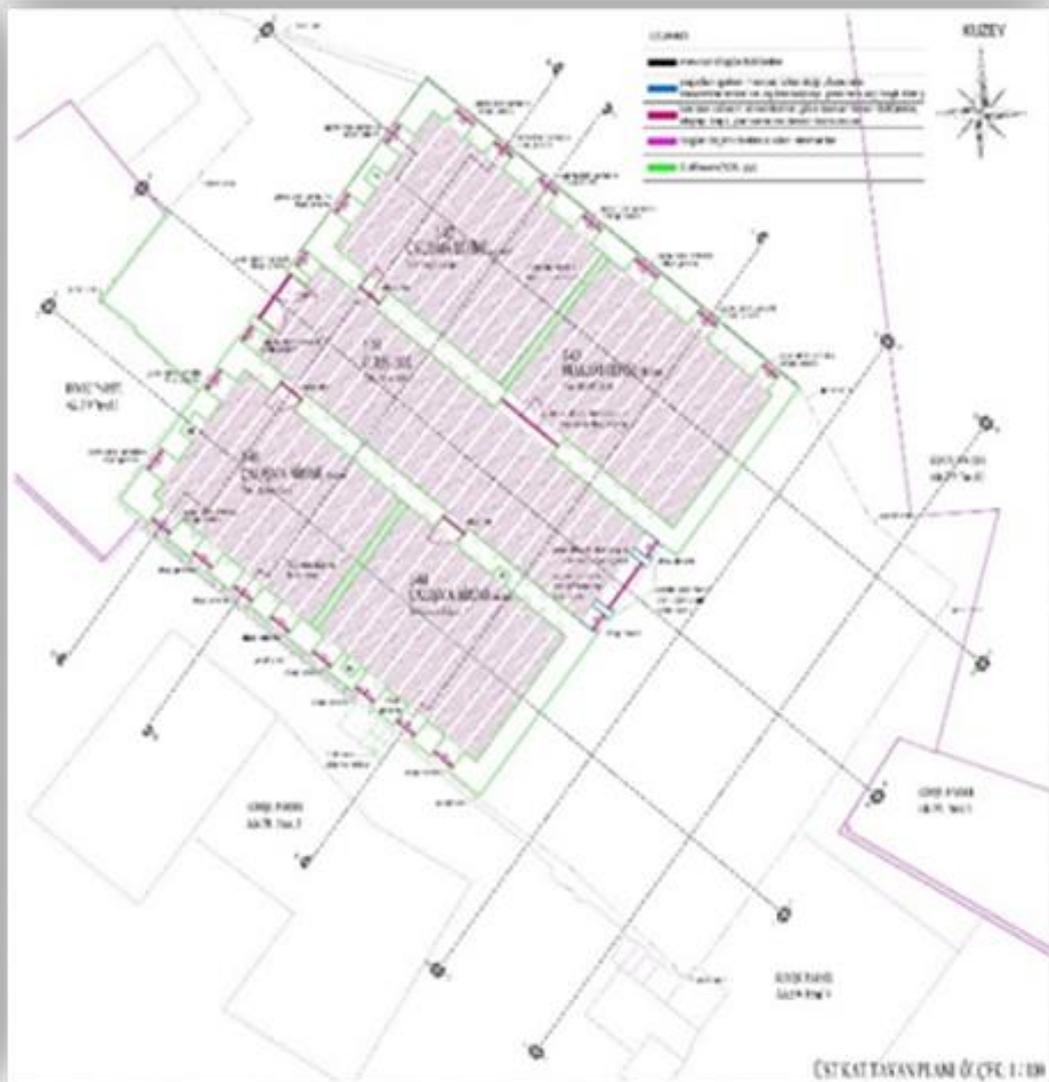
(a) (Mehmet Karahan House)-A similar period example

(b) (Kesra Kanco House)- A similar period example

Figure 7. The wooden beamed floor completed according to the information obtained from the examples of similar periods and the people around the building

It is the uppermost part and the last floor of the building. There is no parapet on the terrace floor, which has a square plan scheme. There is no building element on this floor. The upper floor was used as the government house. Some traces of the original flooring remained on the upper floor, and today, some of it is cut stone and cement-based screed. Floor coverings were completed according to the original floor coverings used in the entrance-hall of the building and similar structures. As a result, it has been determined that the floor coverings of the spaces are a material that is considered as cut stone. The ceiling of the upper floor collapsed over time and was supported by reinforced concrete beams and covered with a reinforced concrete screed. The ceiling slab, which was a reinforced concrete screed, was removed and replaced with wood-beamed slab, which was completed with soil, according to the information obtained from examples from similar periods and the people around the building (Figure 7).

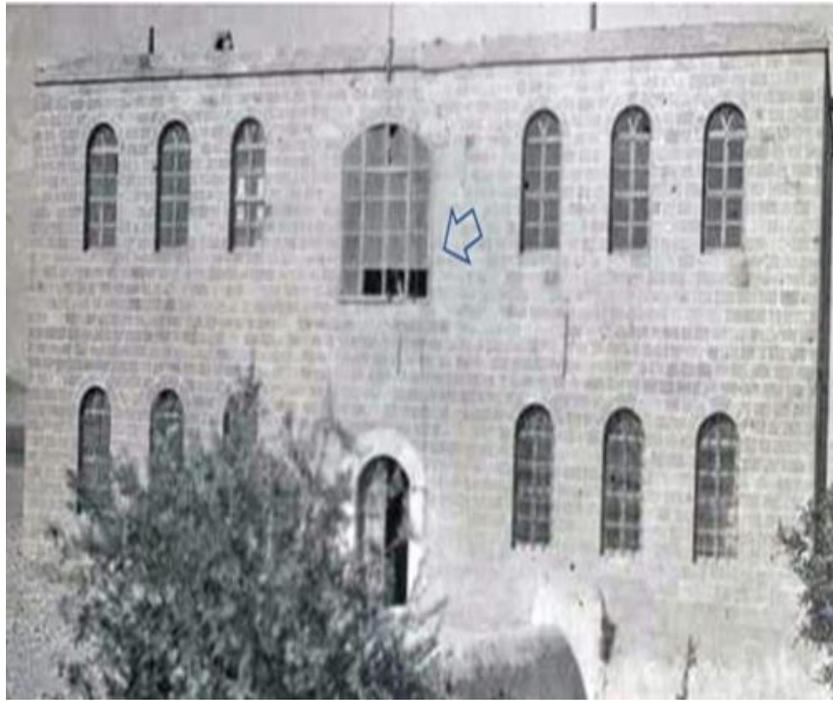
**Figure 8.** Wooden joinery found in a similar building sample (Former Kızıltepe Government Building)

The upper floor is reached by a stone-stepped staircase in the northwest wing, which is completed according to the existing traces and the column capital found in the building. The entrance to the building is through the pointed arched door in the northwest. Based on examples from the similar period, the wooden door was converted to its original form. The pointed arched iwan on the southeast façade wall in 1-01 Entrance-Hall and the windows on both sides were opened in line with the existing traces from the building. Based on examples

from similar periods, the wooden joinery was converted to its original form (Figure 8, Figure 5g).

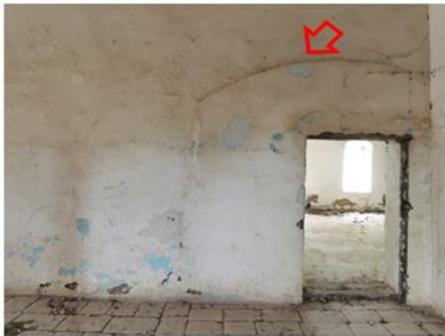
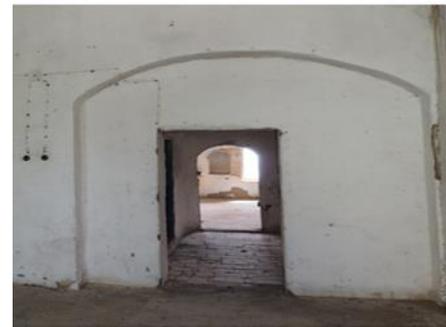
**Figure 9.** The stone wall, which was built later, that provides the transition to 1-03 office room on the northeast facade wall of 1-01 Entrance-Hall

The stone wall, which was built later, which provided the passage to 1-03 office room on the northeast facade wall of 1-01 Entrance-Hall, was removed and wooden joinery was used based on examples from similar periods (Figure 9).
